| <b>PATHWAYS</b> | | | | Rhodia Martinez<br>Peyton Slough | <b>ILLUSTRATION OF PATHWAYS<br/>OF CONTAMINATION TO<br/>NEW ALIGNMENT</b> | <b>Figure<br/>3.5-1</b> |

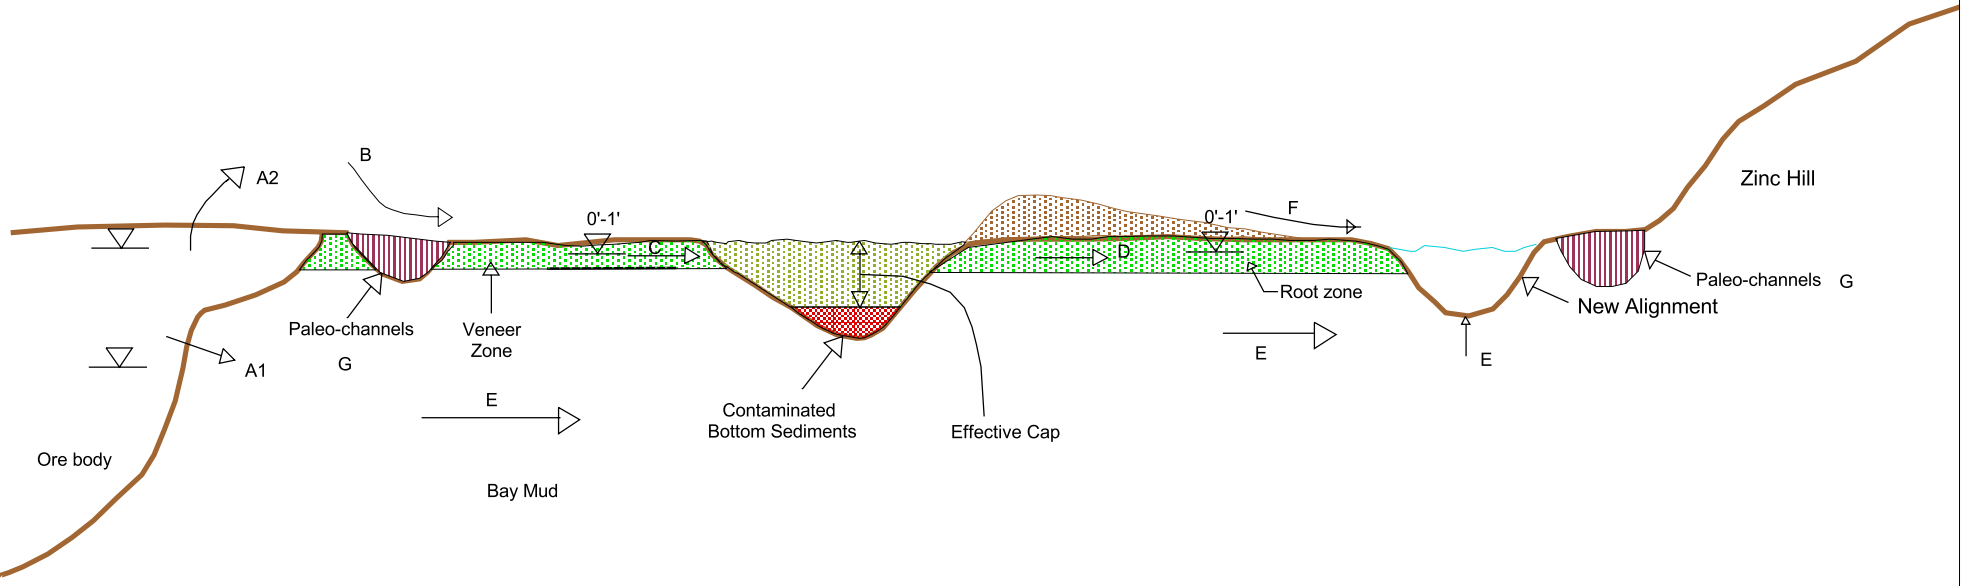
| A Flow from Ore Body<br>(groundwater and daylight)<br>B Runoff from the Rhodia site | C Groundwater transport<br>from west of the existing<br>Slough through the cap<br>D Shallow groundwater<br>transport into the new<br>alignment | E Deep groundwater transport into<br>the new alignment<br>F Erosion of contaminated surface<br>soils<br>G Flow from contaminated areas<br>through the paleo-channels | | Project No. 51-00070007.00 | | |
